ISLAND HILLS GOLF CLUB
458 LAKELAND AVENUE
SAYVILLE, NY 11782

**PHASE I
ENVIRONMENTAL SITE ASSESSMENT
(ASTM 1527-13/40 CFR PART 312)**

PWGC Project Number: RSL1801

JUNE 2018

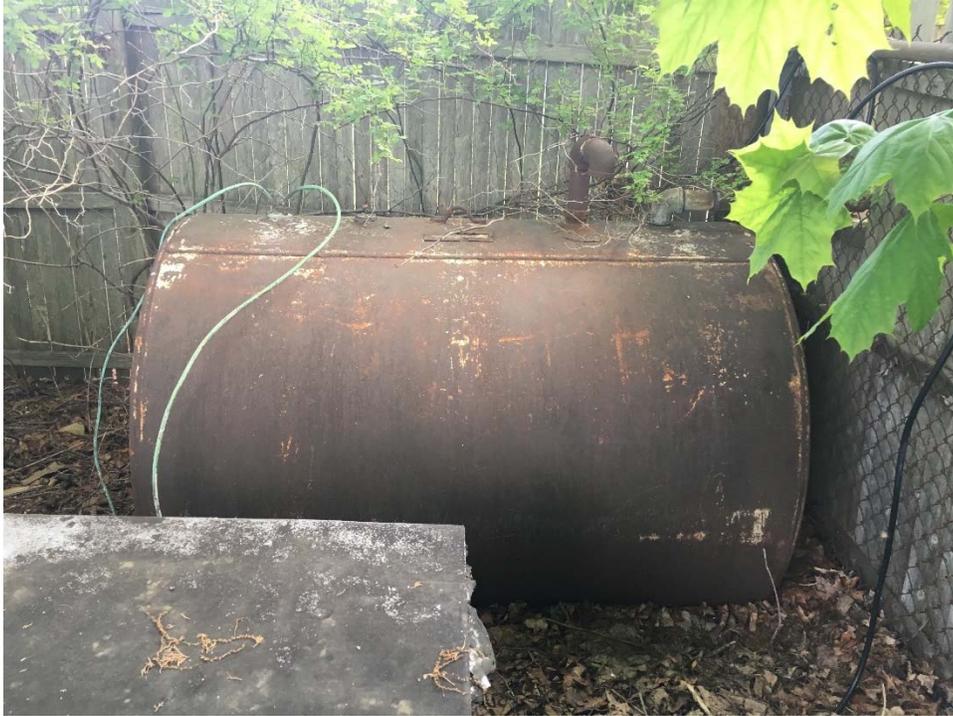
A 550 gallon AST was observed behind the former Pro Shop. The AST is in direct contact with the soil, but no obvious leaks were observed.

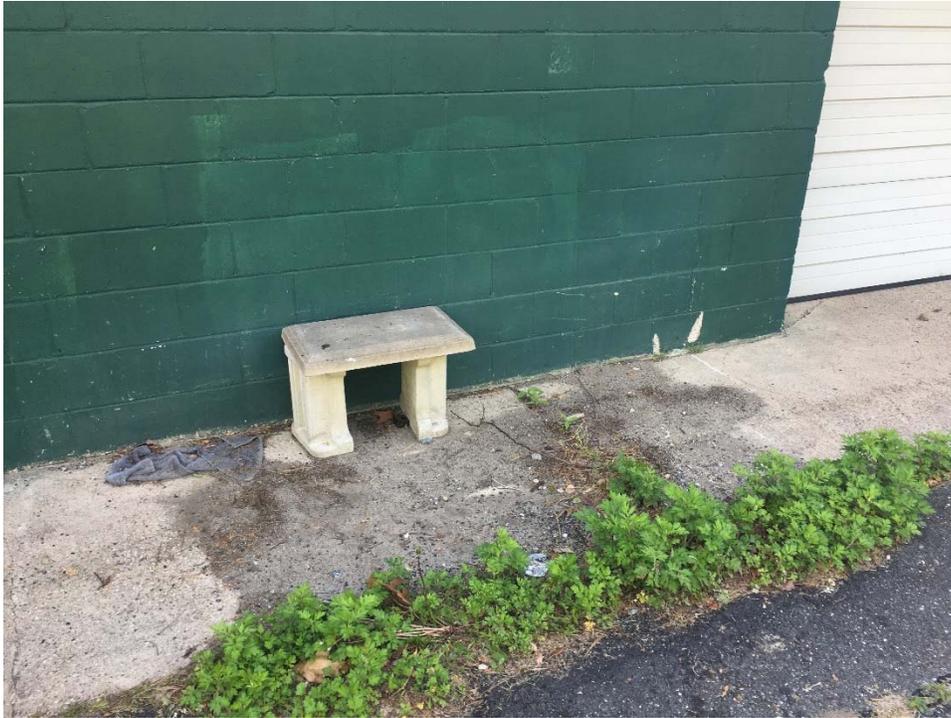
A 275-gallon AST was previously located adjacent to the SMB. *De minimus* staining is observed where the AST was located.

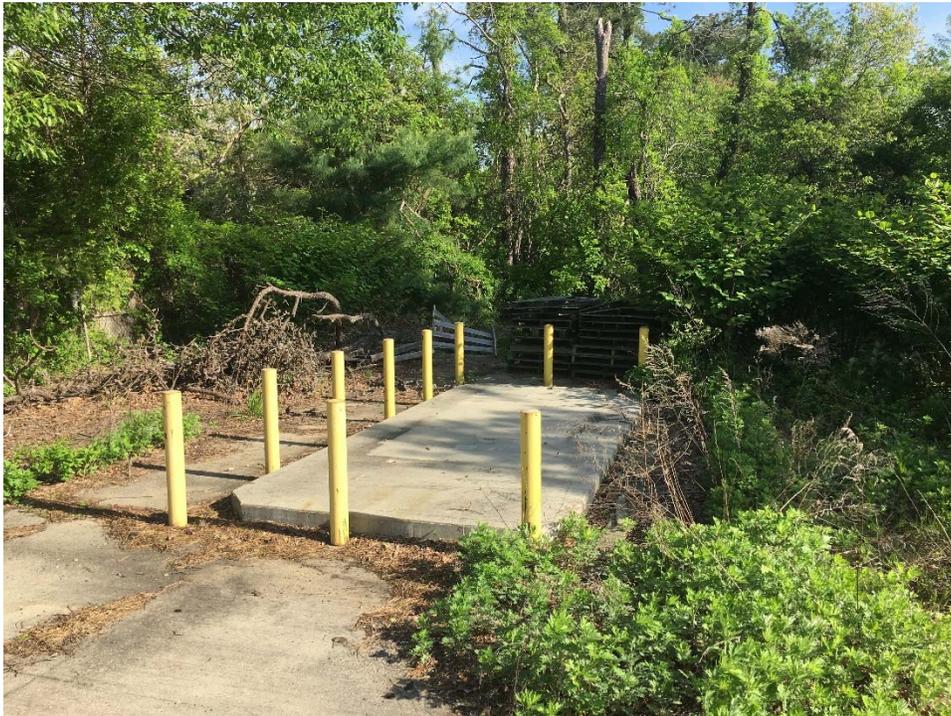
A 2,000-gallon AST was previously located on this concrete slab north of the SMB.

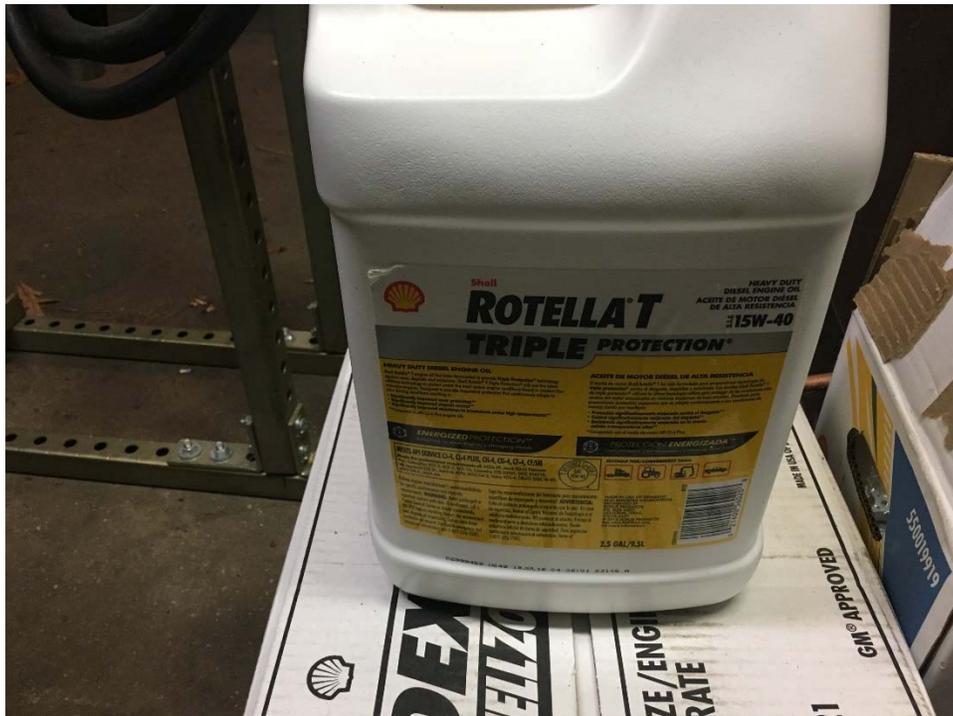
Antifreeze and lube oil was stored in the SMB. No leaks or stains were observed.

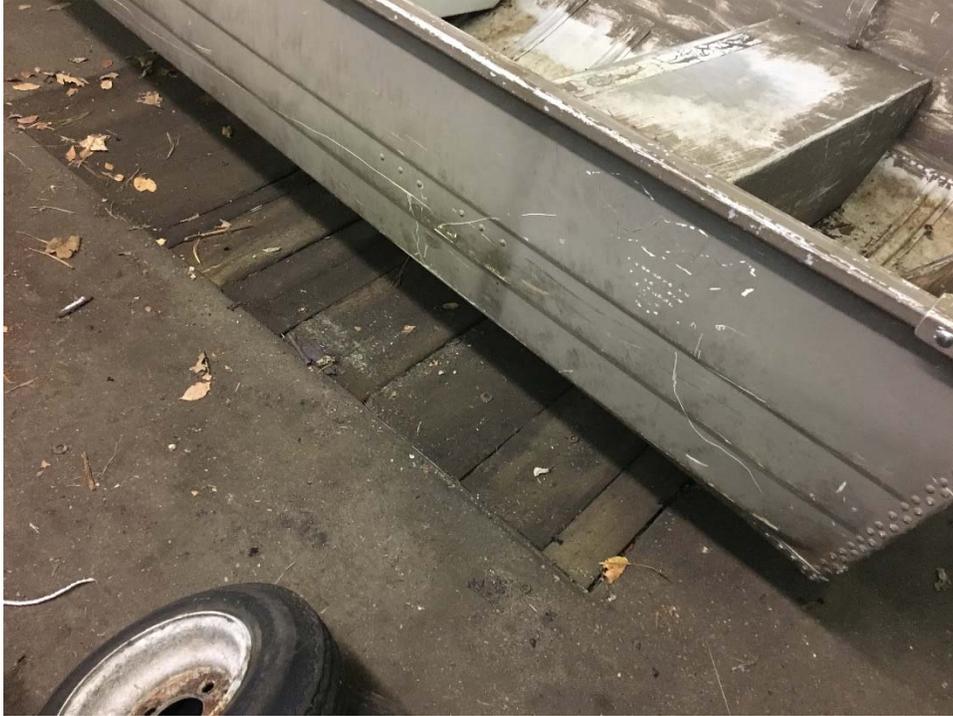
A sealed maintenance pit was discovered in the SMB.

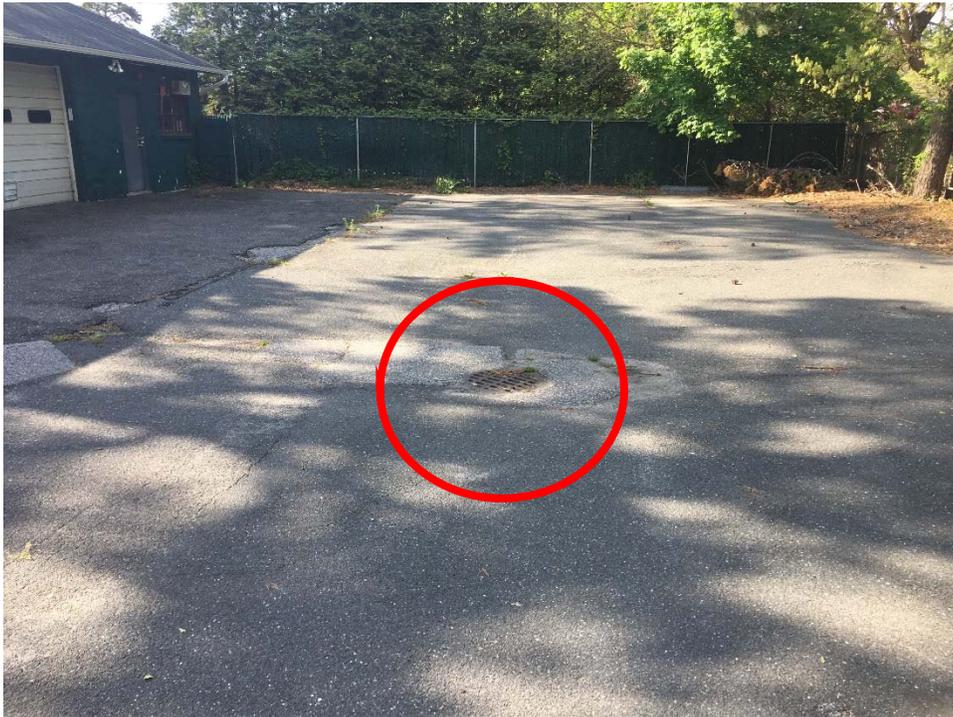
A stormwater drain was observed adjacent to the SMB.

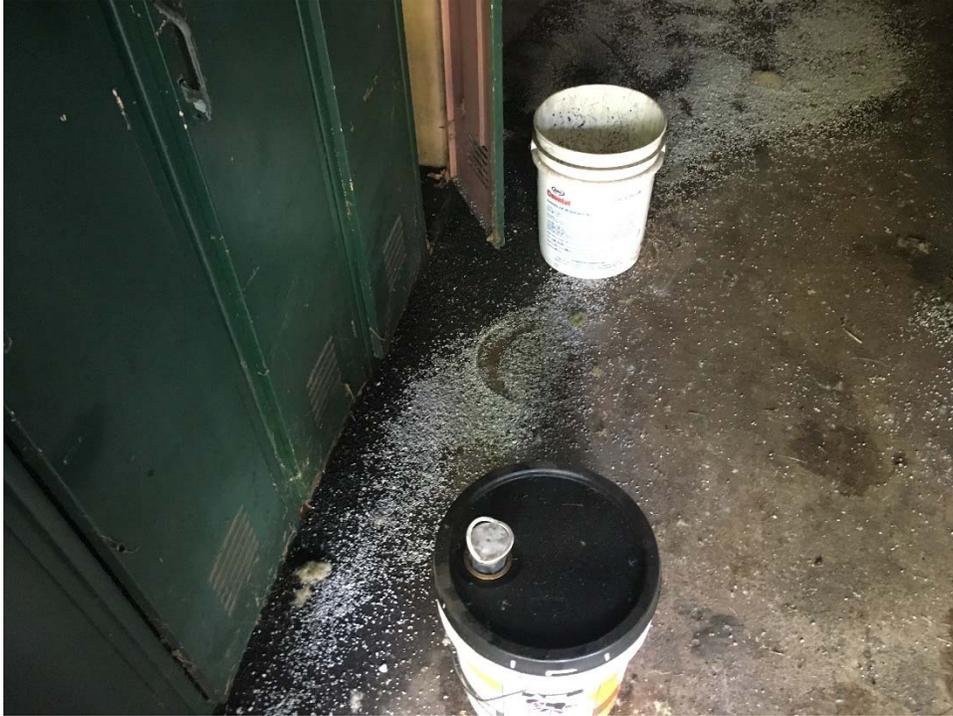
Some *de minimus* petroleum staining with speedy dry absorbent was observed in the SMB in the vicinity of the lawn mower maintenance equipment. No cracks were observed in the concrete.

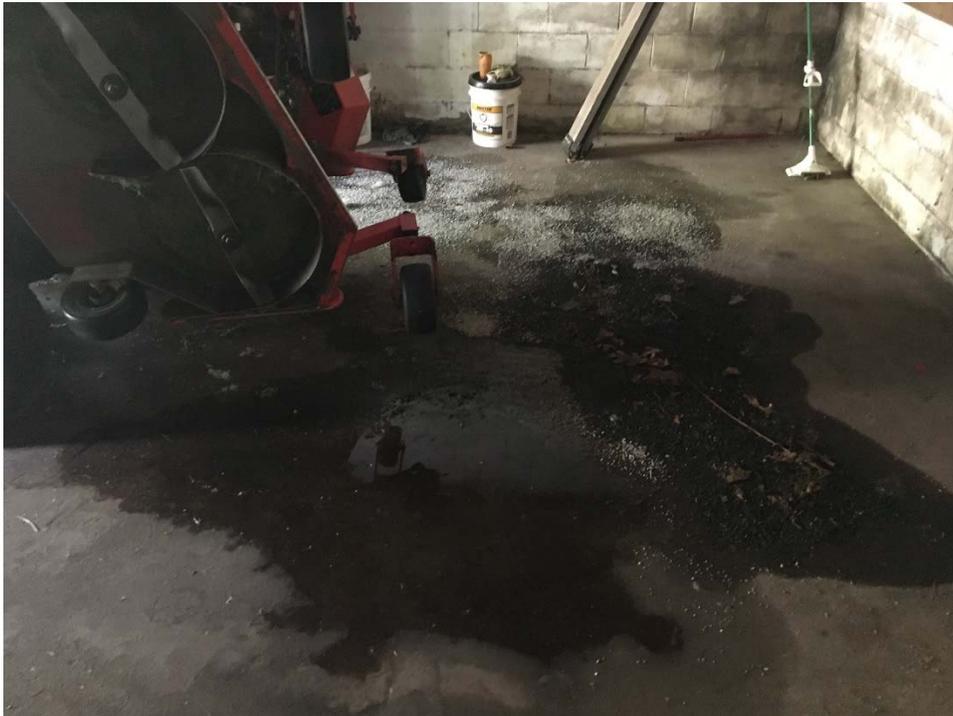
Water staining was observed on the concrete floor of the SMB.

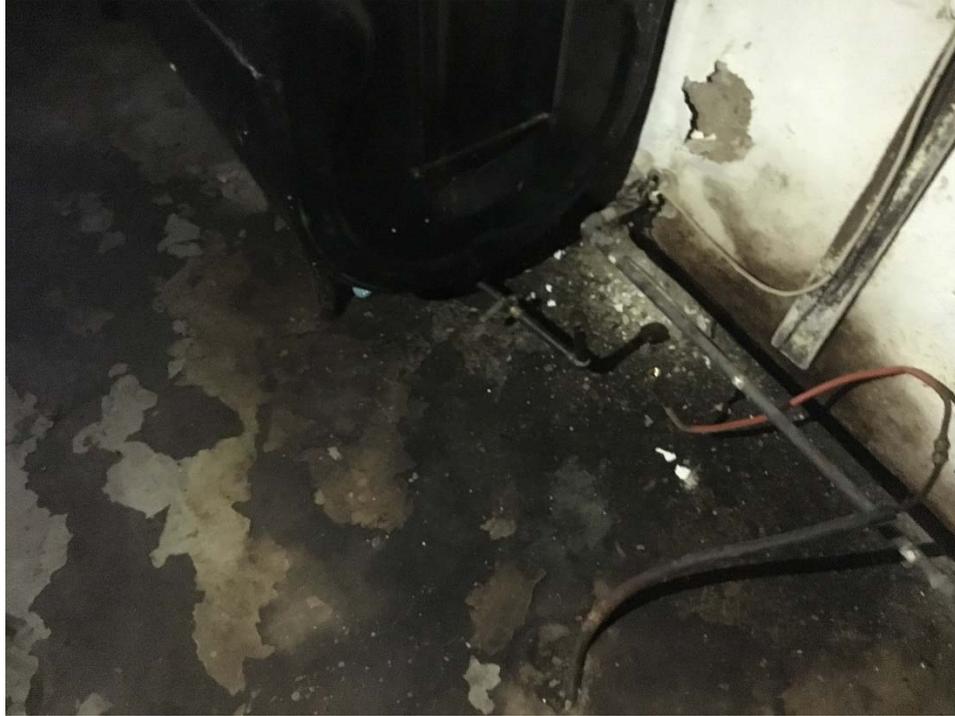
Minor staining was observed on the concrete floor of the basement.

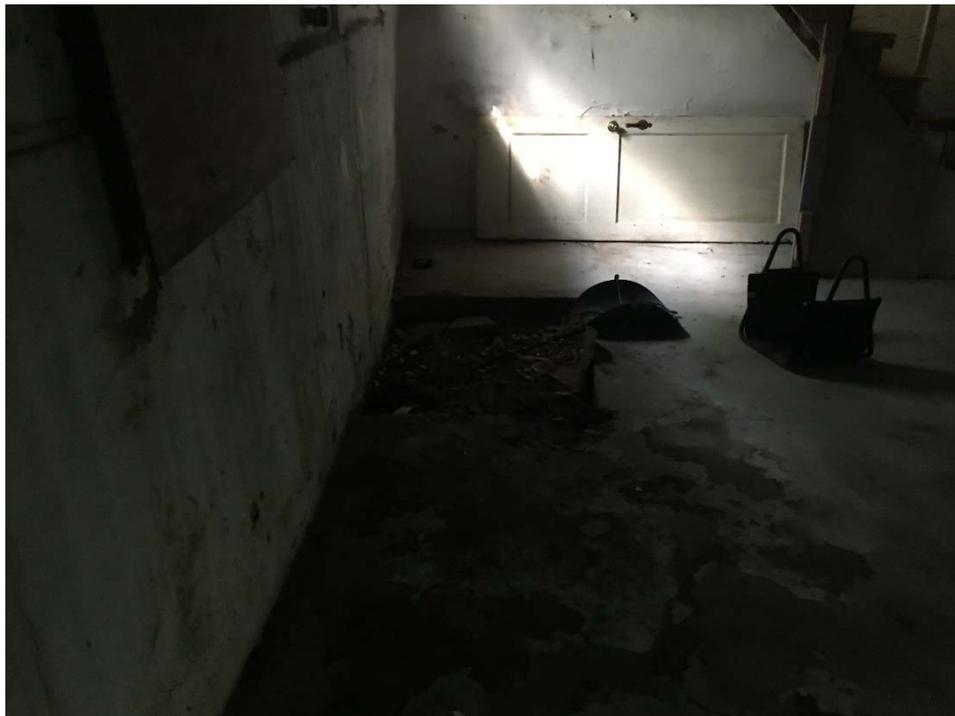
There was also exposed soil located in the basement. The soil did not appear to be contaminated, as no staining or odors were observed.

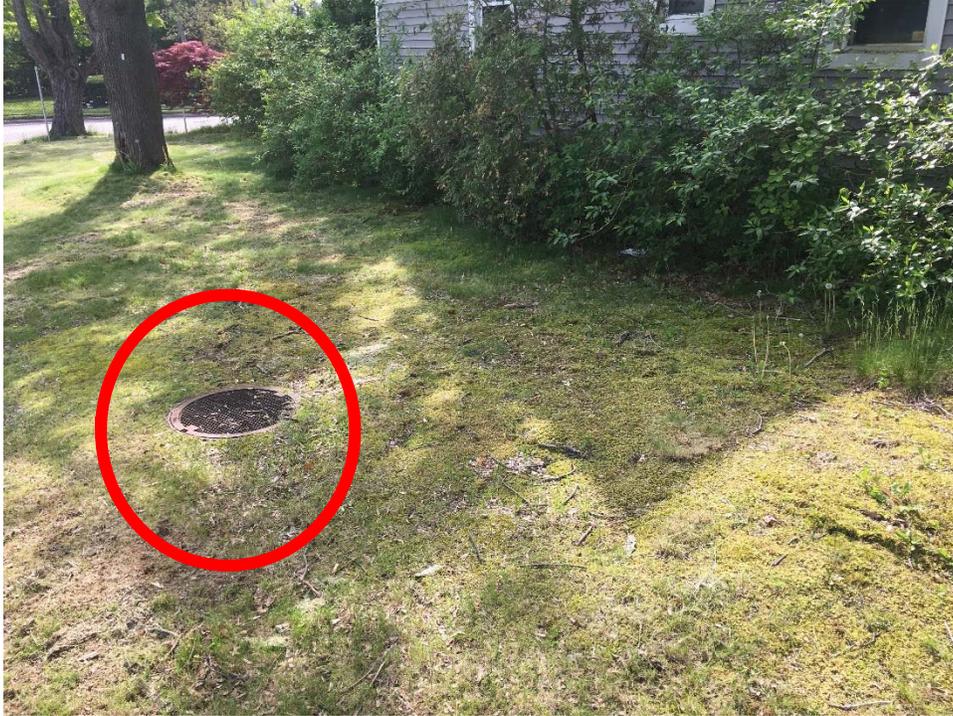
A sanitary manhole was observed on the property of the northern residential home.

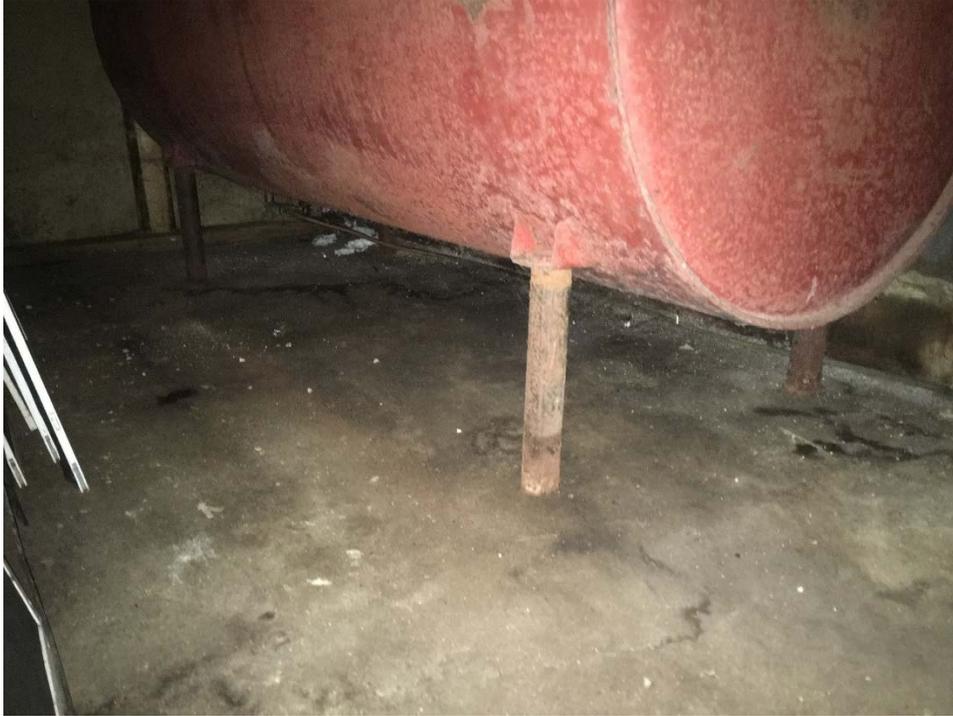
A 275-gallon AST was observed in the basement of the southern home.

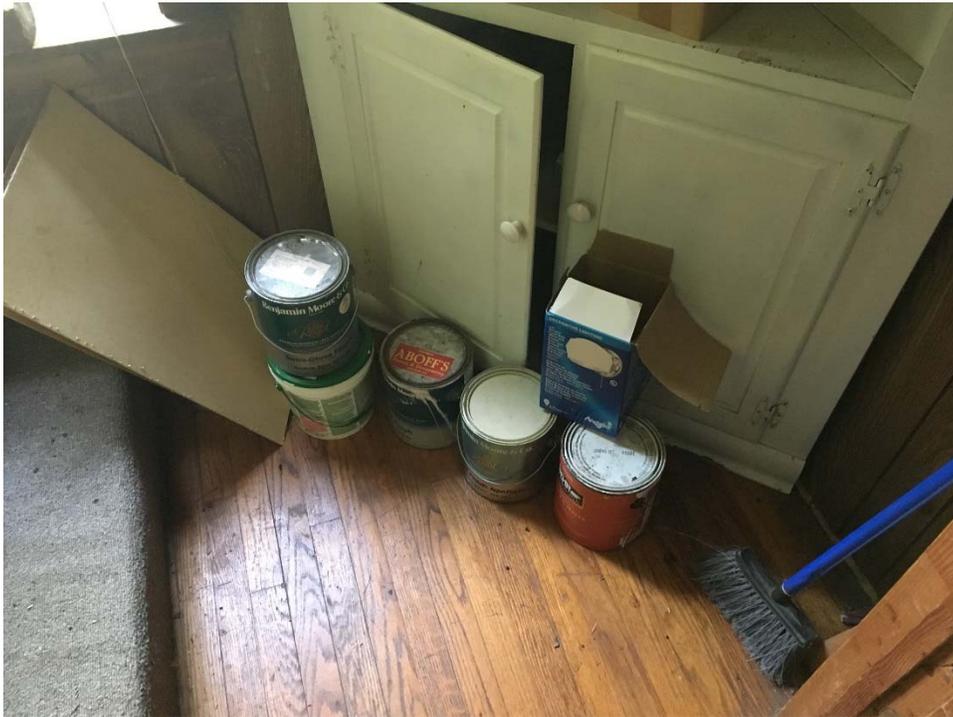
Stored paint cans were observed inside the south house.

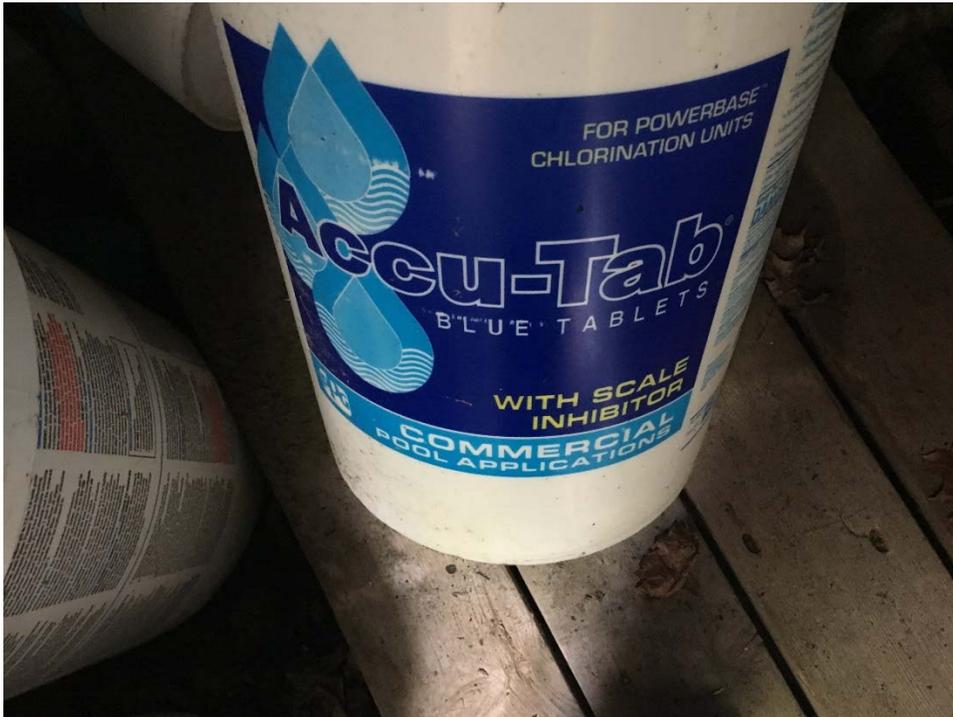
Pool maintenance chemicals were observed in the pool house. The products were properly stored, with no staining or leaks observed.

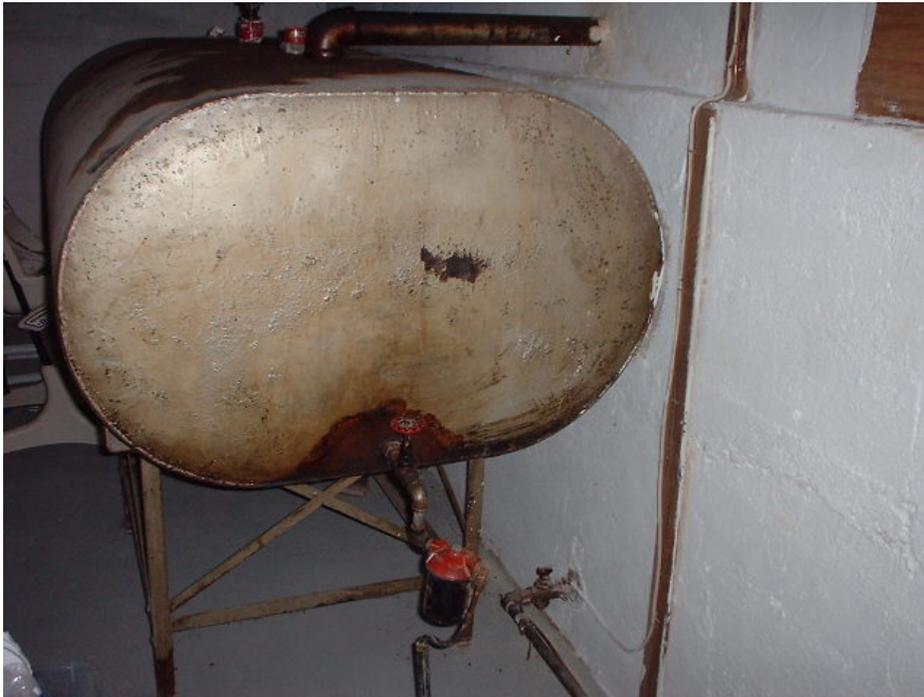
Photo 7 – View of the tank which was present in the northern residential home. No leaks or spills were observed.

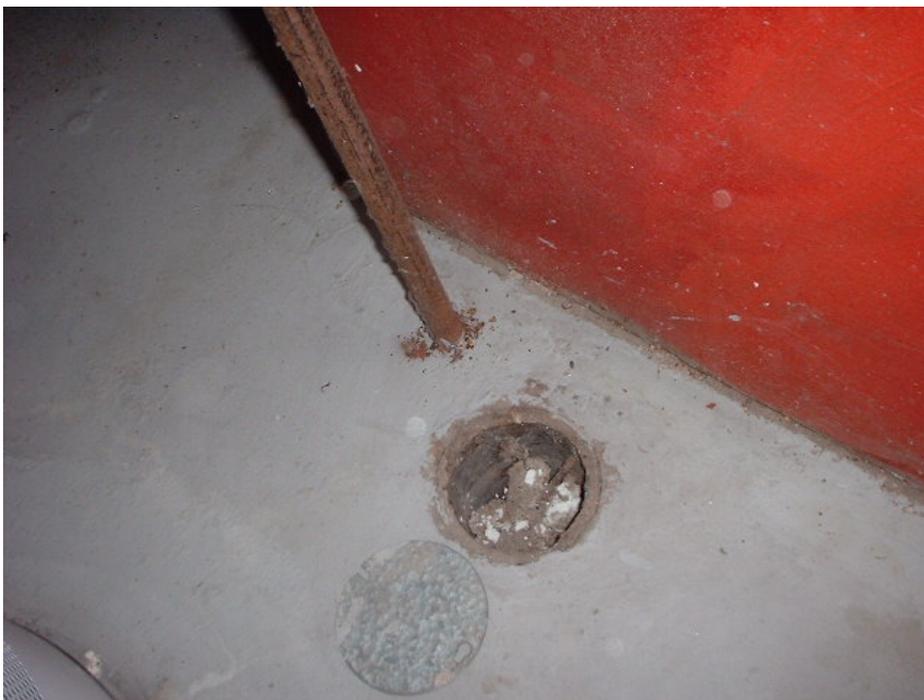
Photo 8 – View of the floor drain which was present in the northern residential home. No signs of spills were observed near the drain.

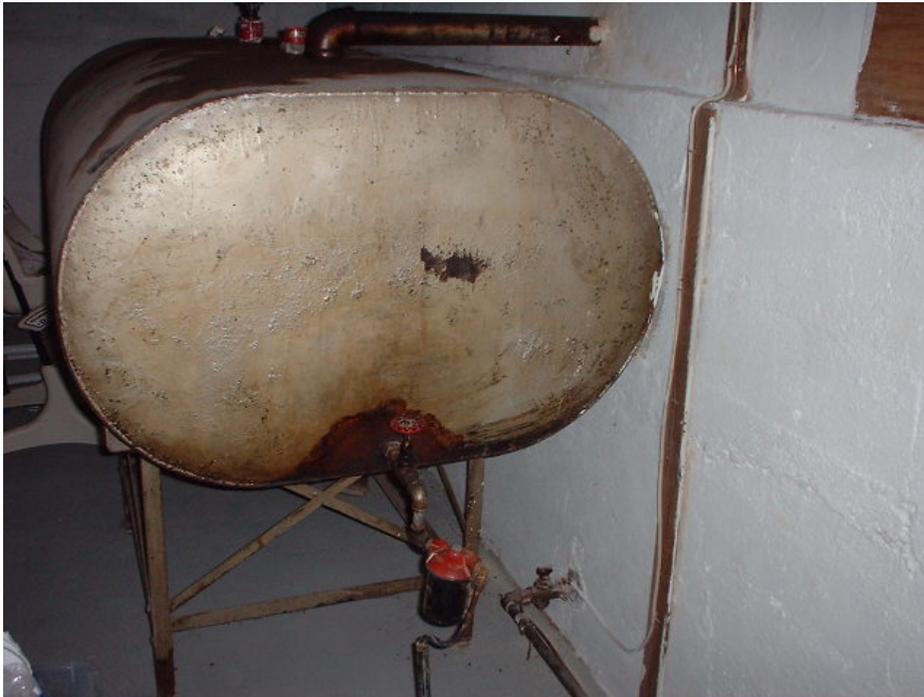
Photo 7 – View of the tank which was present in the northern residential home. No leaks or spills were observed.

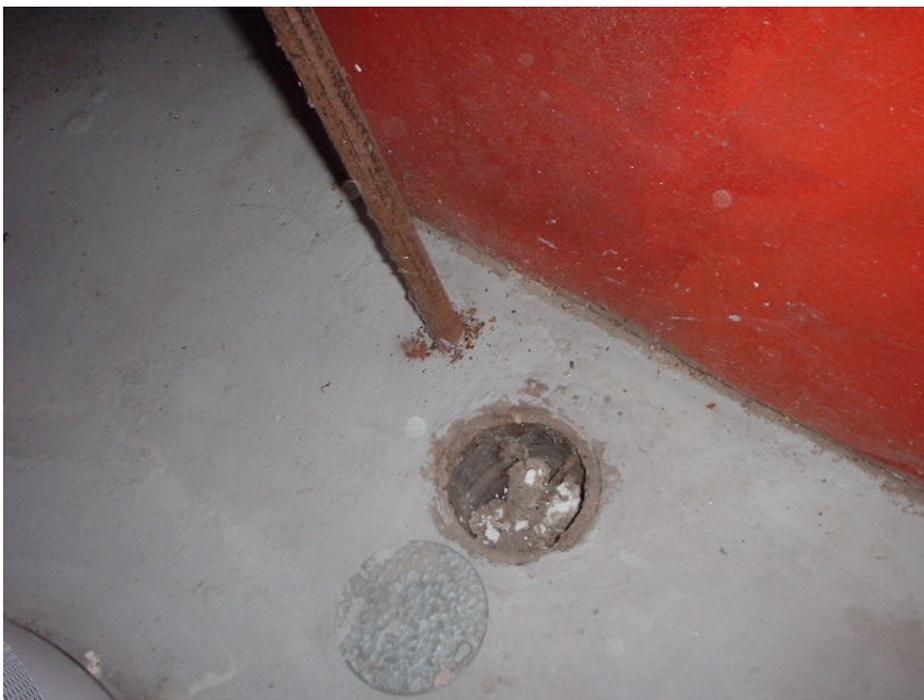
Photo 8 – View of the floor drain which was present in the northern residential home. No signs of spills were observed near the drain.
