ISLAND HILLS GOLF CLUB
458 LAKELAND AVENUE
SAYVILLE, NY 11782

**PHASE I
ENVIRONMENTAL SITE ASSESSMENT
(ASTM 1527-13/40 CFR PART 312)**

PWGC Project Number: RSL1801

JUNE 2018

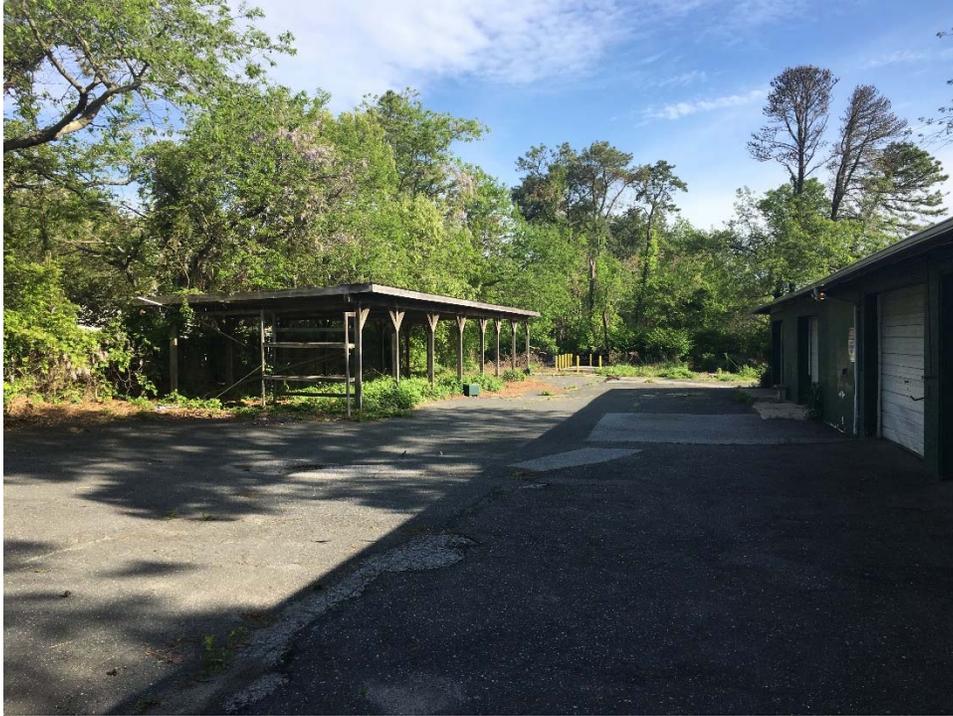
An asphalt-paved lot was observed adjacent to the south maintenance area.

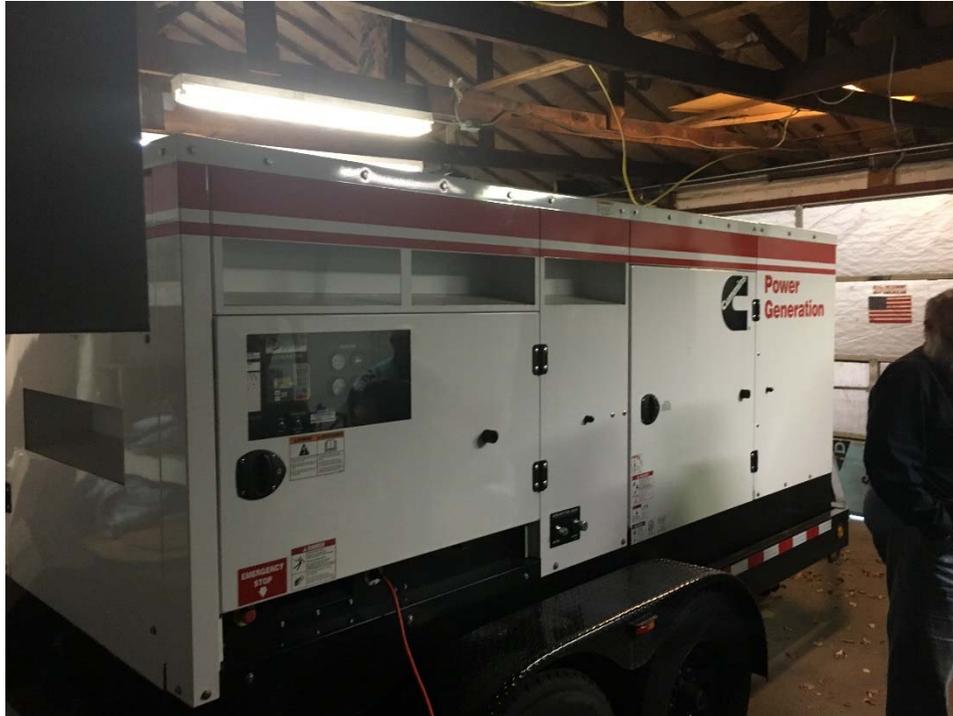
A generator in the SMB. This generator was reportedly not used at the site and is only being stored there.

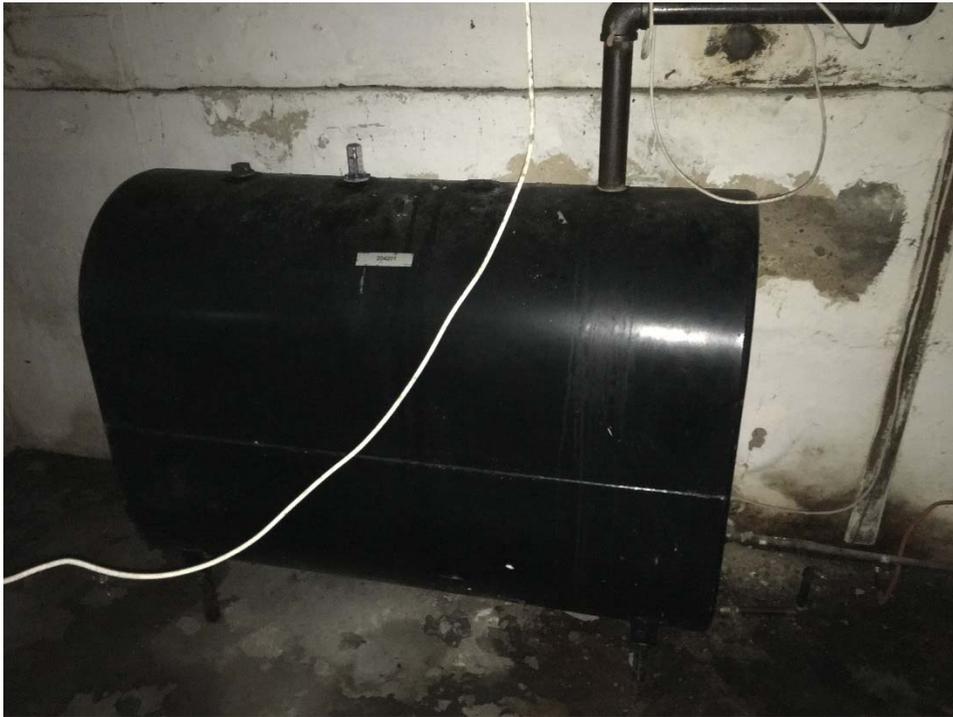
- Three ASTs were identified at the site: one 275 gallon AST located in the basement of each residential house and one 550 gallon AST located adjacent to the pro-shop and in direct contact with the soil. The ASTs were in varying conditions from good to fair and there was no evidence of leaks from the ASTs. The ASTs are still partially full of liquids and over time, the ASTs, without proper maintenance may fail. The presence of these ASTs represents a REC.

A 275-gallon AST, presumably used for fuel oil, was located in the basement of a residential home located on the northern portion of the site.

- Partner agrees that, prior to construction activities, all remaining environmental structures (stormwater drains and cesspools) should be closed and sampled as appropriate. Any remaining ASTs should be cleaned and properly disposed of. Soil beneath each AST should be sampled if there is any indication of staining, leakage, or other visual signs of possible AST failure.

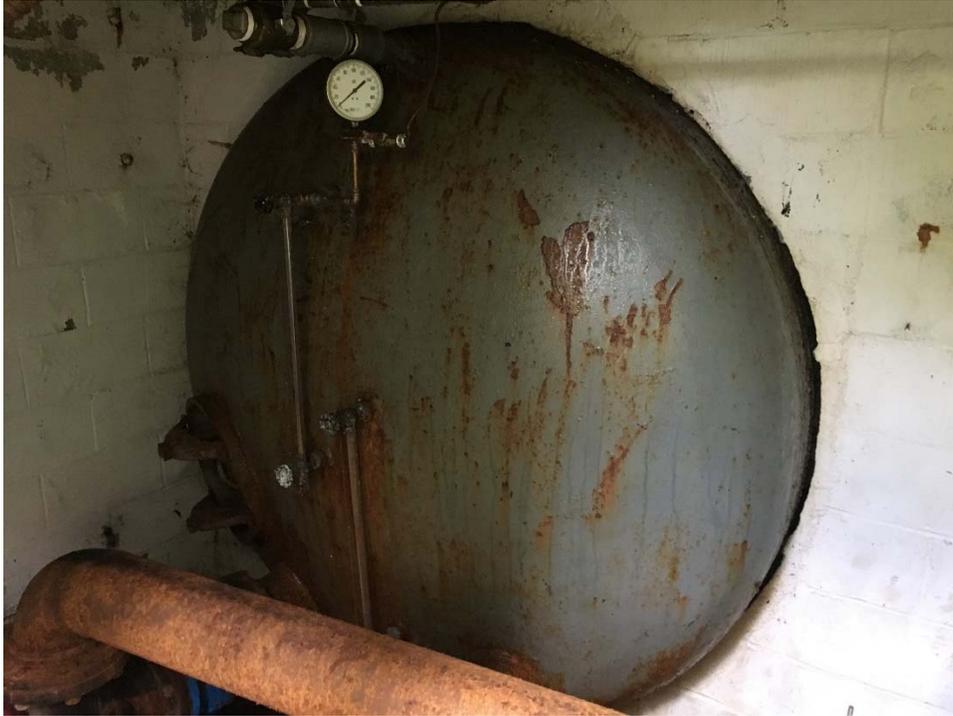
A UST used to store water relating to the site's irrigation is located in a maintenance pit near a private well on the west side of the golf course.

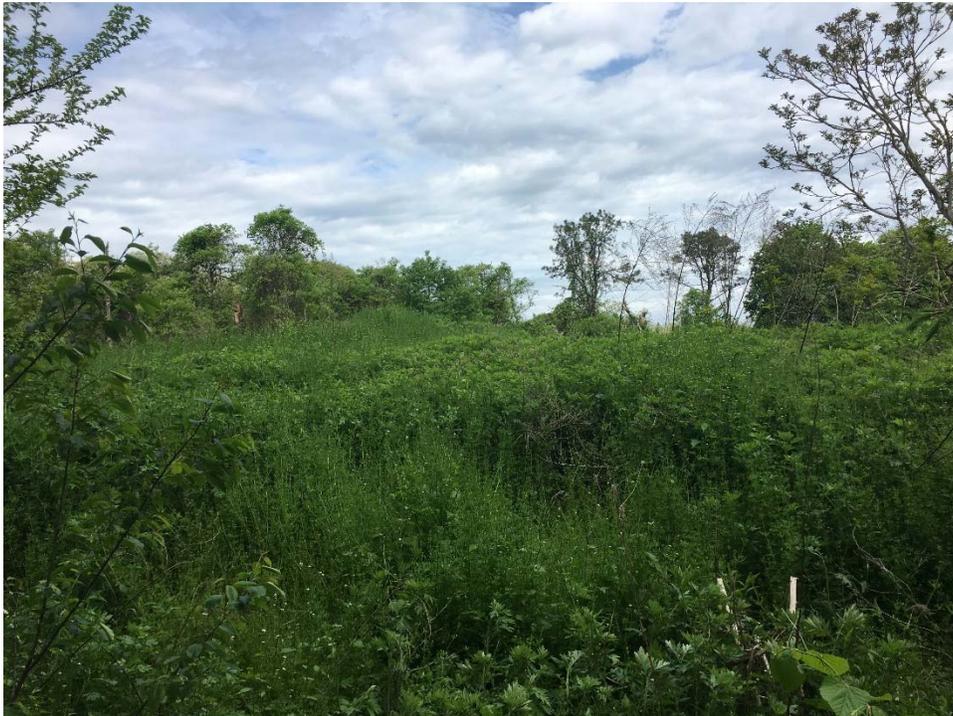
The potential location of a landscaping debris pile is located at the western portion of the golf course. The area was overgrown; therefore, the surface could not be inspected to determine if the debris pile was still there.

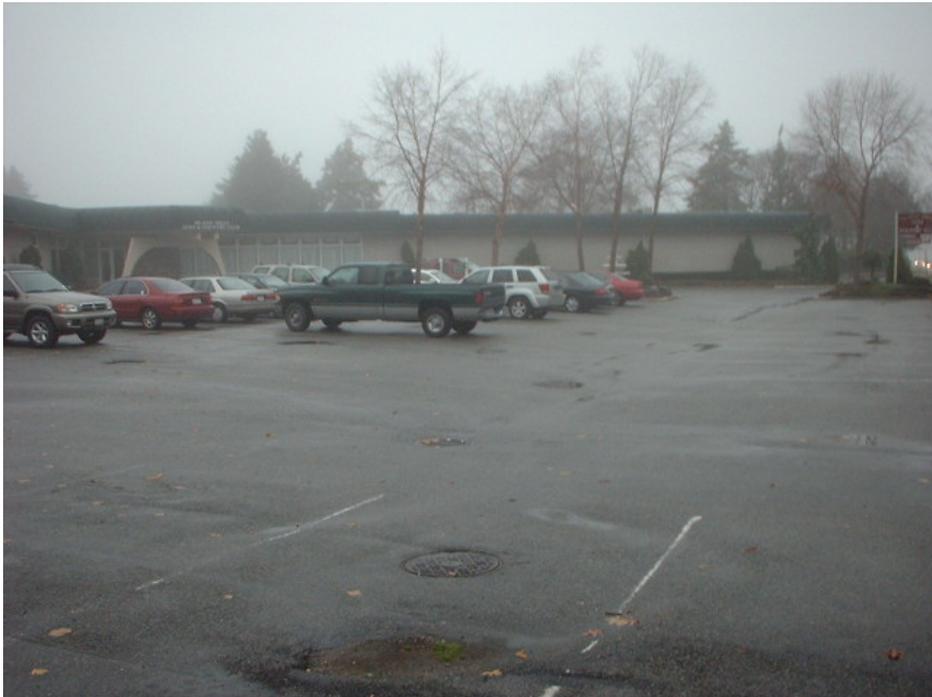
Photo 1 – View of the parking lot which is located in the northern portion of the subject property. Stormdrains, cesspools, and overflow covers are shown in the photo.

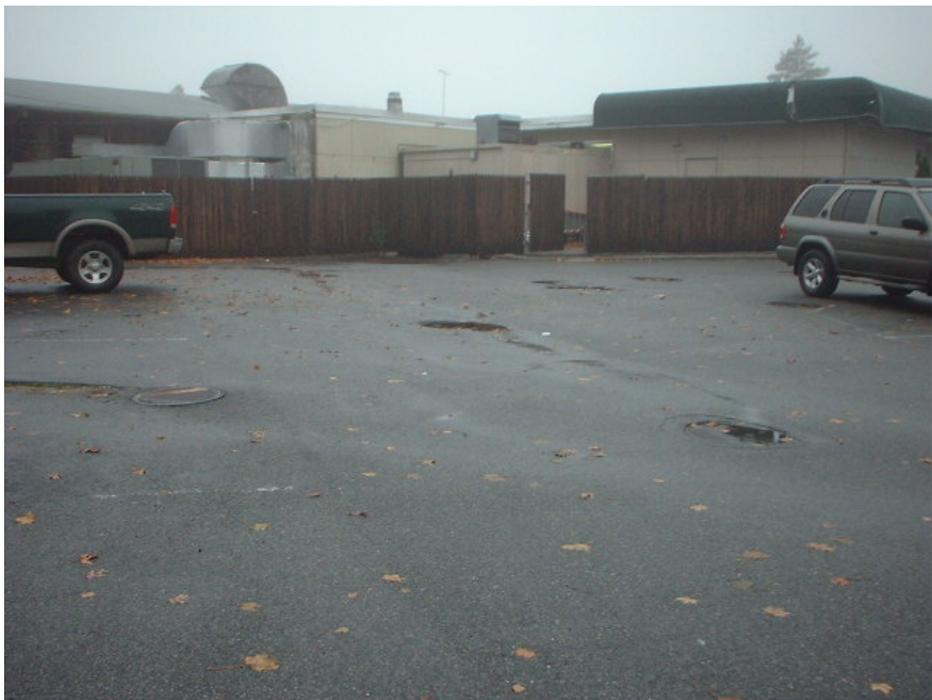
Photo 2 – Additional view of the parking lot showing additional cesspool covers.

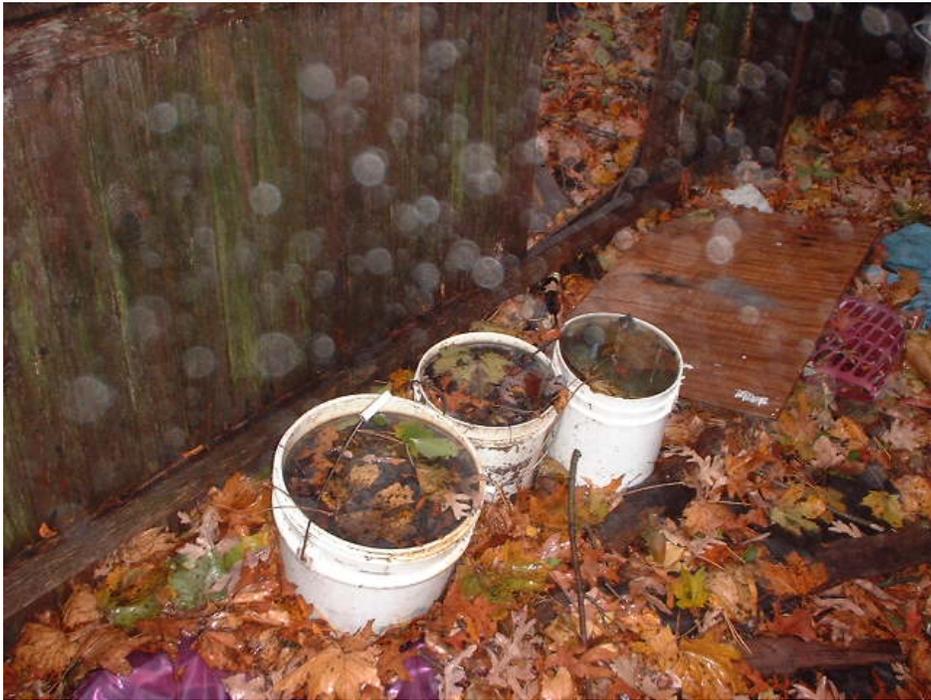
Photo 5 – View of buckets with an oily residue which were present in the rear of the south residential home.

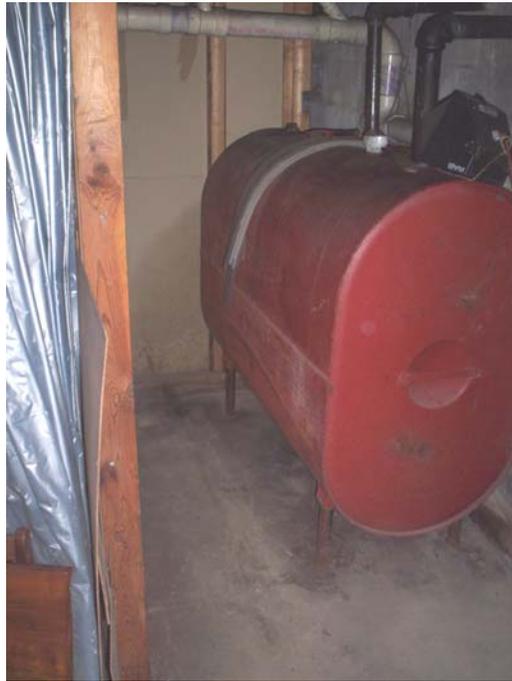
Photo 9 – View of the fuel oil tank which was present in the basement of the southern residential home.

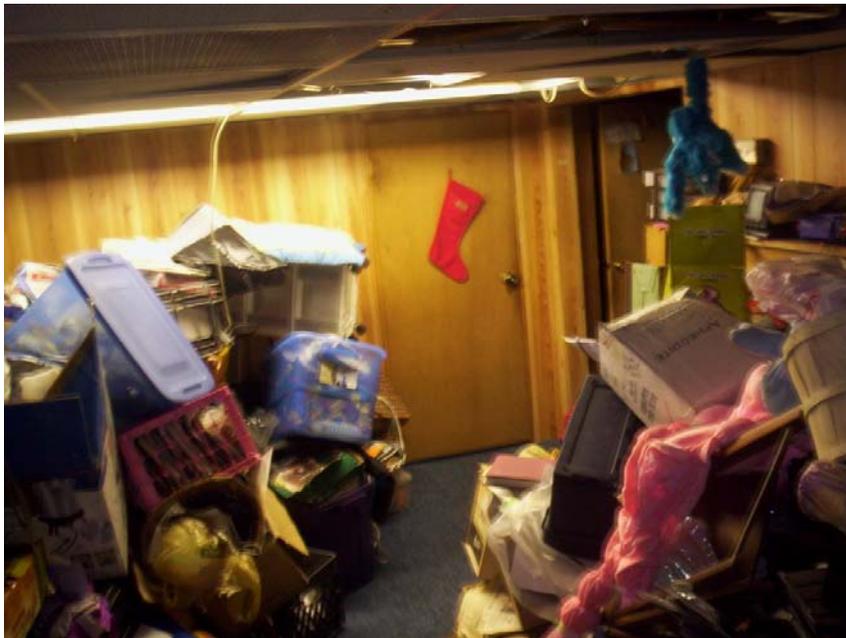
Photo 10 – The entire basement of the southern home could not be checked for floor drains since it was partially finished.
